Work on the school house has begun

As it stands at the end of May 2014

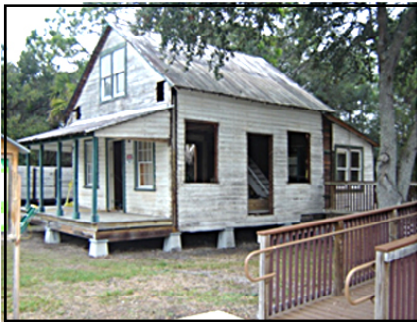
#1 - Vinyl siding removed

Prior to signing the contract, volunteers removed the vinyl siding and drywall that we believe was installed sometime in the 1990s. Removing the drywall showed that the main entrance was most likely on the side of the building. We are not 100 percent sure, but we believe the rear room, added in 1911, was originally a small porch. After the hurricane of 1908 it was made a classroom. (*#1 Vinyl siding removed*)

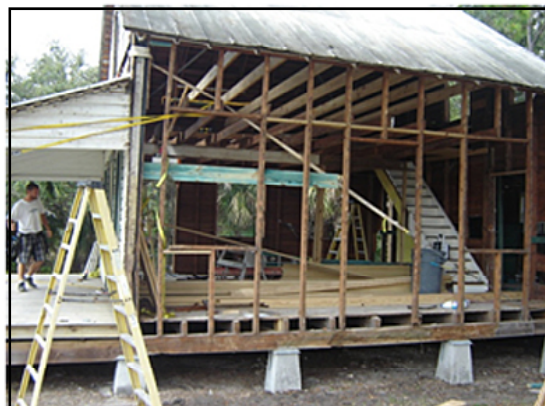
#2 New Rafters

Sometime after the Schoolhouse was closed in 1927, it was turned into a residence. The ceiling was lowered and a second floor bedroom was added. Removing the bedroom leaves space for a storage attic. The photo (*02 New Rafters*) above shows the new higher rafters and two old rafters. The 1908 hurricane did a lot of structural damage to the School. The School had a noticeable forward lean. We were able to correct the lean using “come a longs” straps—see strap at top of front corner.

Raising the ceiling meant removing the current rafters and installing new rafters to their original 1904 position.

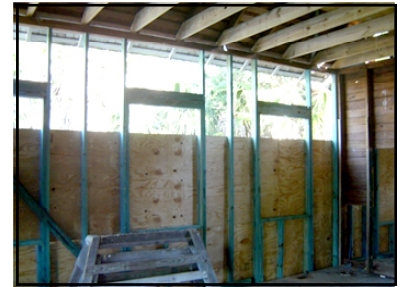
#3 Plywood sheeting

After removing the siding we found that the original wall studs were slightly warped. They were replaced with pressure treated studs. Plywood sheeting was installed to give strength to the structure. (*#3 Plywood sheeting*)

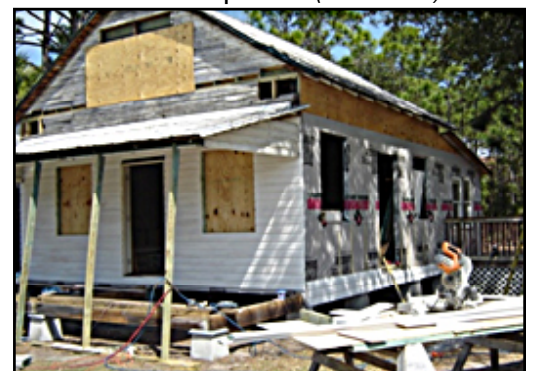
#5 Rafters and new siding

You notice the framing for the windows are in place and you get a better look at the height of the new rafters in the below photo. (*#5 Rafters*)

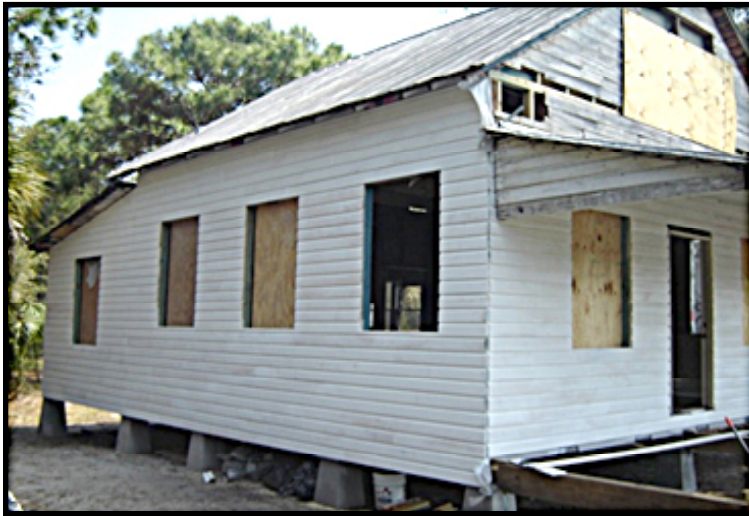
#6 No porch and new siding

In the photo above (*#6 No porch and new siding*) you see the porch was removed and the contractor is beginning to install new siding on the porch and along the side. You can also get a look at the original siding over the porch. In this photo you see the siding has been nailed up. (*#6 siding*) The painter primed the siding before the contractor nailed the siding. Notice the old metal roof is still attached. The metal roof was not original, sometime after 1904 the cedar shake shingle was covered with metal. In this photo (*#7 Cedar shakes*) you can see the original cedar shakes.

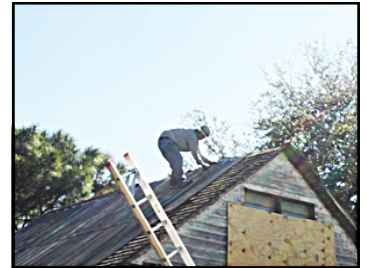
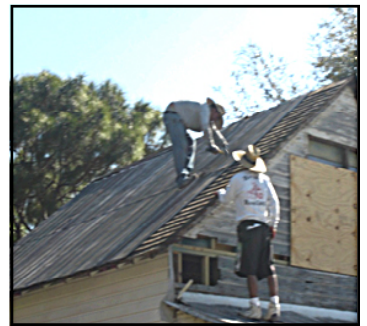
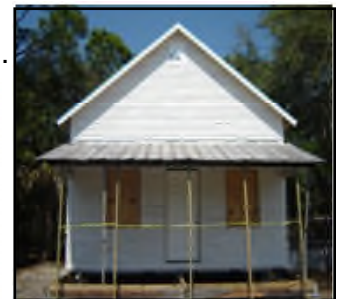
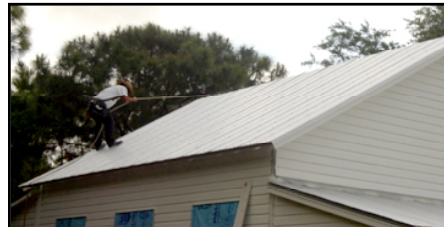
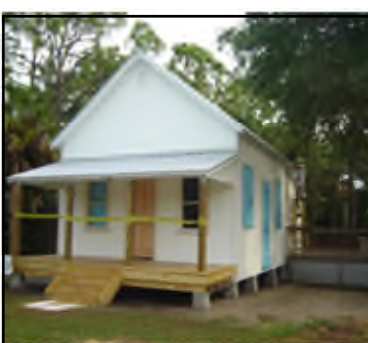
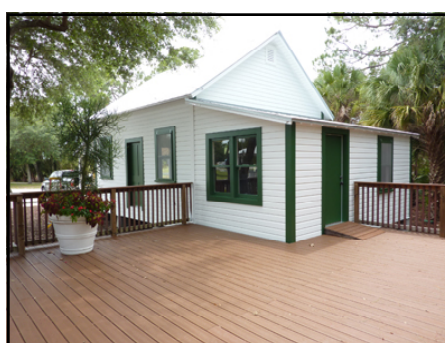
These photos show the roofers removing the old metal roof and installing the new metal. As mentioned before you can see the cedar shakes. The roofers said the old shakes were in good condition. When they started the removal of the old metal the men did not wear any safety ropes. Later they donned safety equipment. These photos show the painter applying a finish coat of paint to the siding. You notice that the windows are covered with protective blue paper. The paper will be removed after the windows are painted. The last photo shows the completed porch and exterior of the Schoolhouse.
