Work on the school house has begun

As it stands at the end of May 2014

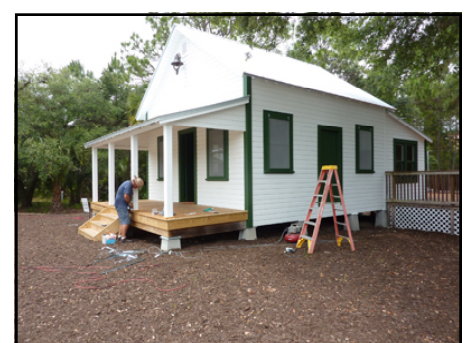
These photos show the roofers removing the old metal roof and installing the new metal. As mentioned before you can see the cedar shakes. The roofers said the old shakes were in good condition. When they started the removal of the old metal the men did not wear any safety ropes. Later they donned safety equipment. These photos show the painter applying a finish coat of paint to the siding. You notice that the windows are covered with protective blue paper. The paper will be removed after the windows are painted. The last photo shows the completed porch and exterior of the Schoolhouse.
